# SmartPlank Design Guide

# SmartPlank®

SmartPlank is a lightweight yet robust structural Laminated Veneer lumber (LVL) manufactured to AS/NZS 4357, sized and engineered to meet or exceed the performance requirements for scaffold planks as defined in AS 1577 Scaffold Planks.

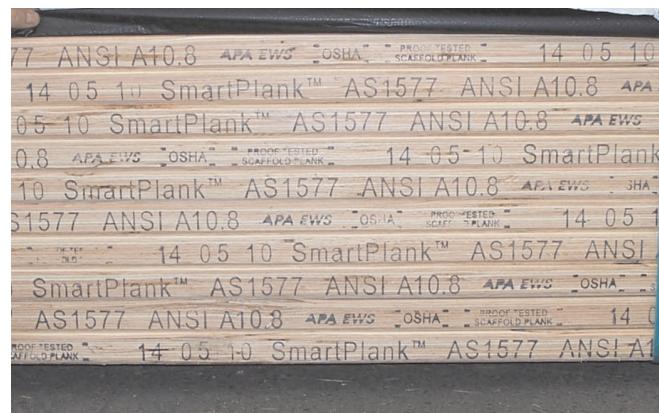
Each SmartPlank is permanently marked along its edge with the following information as per AS 1577:

- ✓ SmartPlank logo and LVL grade (13.2 GPa)
- ✓ AS 1577 reference
- ✓ SAI Global logo and license number
- ✓ JAS-ANZ logo
- ✓ OHSA (United States Occupational Safety and Health Administration)
- ✓ Working Load Limit (WLL)
- ✓ Proof tested
- ✓ Allowable span in metres

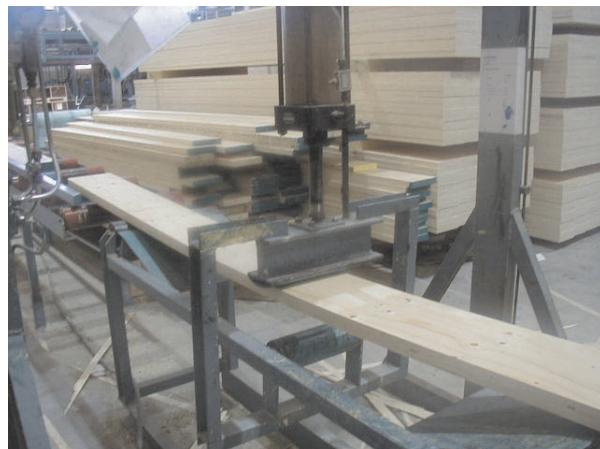
## Proof Loading

All SmartPlanks undergo extensive proof testing within the factory prior to shipment. All SmartPlanks in service should undergo regular proof testing to ensure their structural integrity.

Subsequent proof test load should be twice the Work Load Limit (WLL) and the plank should be tested with critical defects as near as possible to the load point but on the opposite face. For planks longer than their maximum span and where there is no clearly defined suspect weak point, testing of planks in a number of positions and orientation is suggested.

Appendix B of AS 1577 sets out a method for determining the strengths of scaffold planks in bending. Users may develop their own test methods provided that this proof test method meets the requirements of the test as described in the above standard.

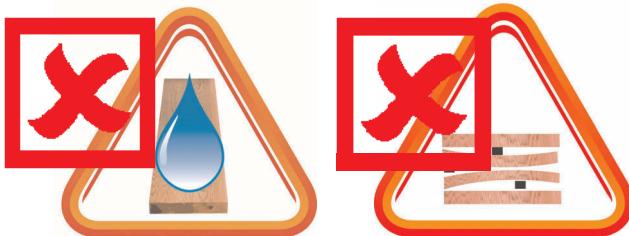
#### Storage

Never allow SmartPlank to be stored where it can come into direct contact with water or damp surfaces.

##### (a) Wet SmartPlanks

Locate stack in a dry, well ventilated area. Stack on bearers or similar supports, 3 per plank, well above the ground to let the air circulate (minimum recommended distance of 300 mm). Separate each layer with spacers (spacers), approximately aligned with bearers below.

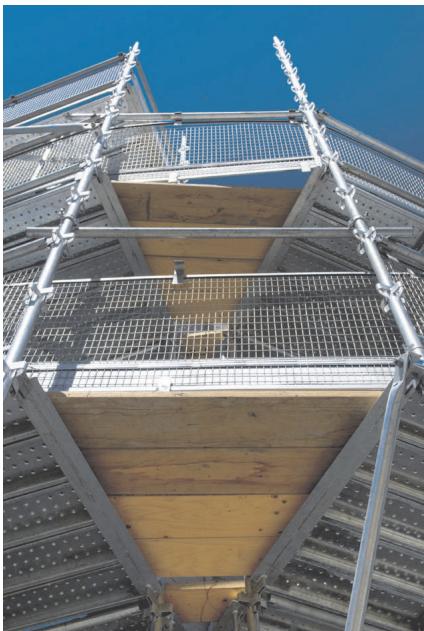
- If under cover, use good timber stacking practice
- If outside, use a weatherproof cover to keep dry and stack as per wet planks.
