# SMART PLANK

**DESIGN  
GUIDE  
EDITION 1**  
2026

# SmartPlank®

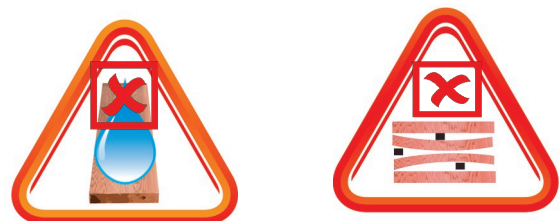
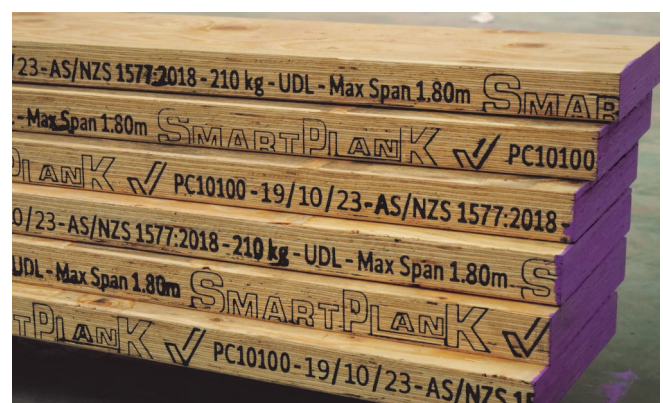
Locate stack in a dry, well ventilated area. Stack on bearers or similar supports, 3 per plank, well above the ground to let the air circulate (minimum recommended distance of 300 mm). Separate each layer with stickers (spacer), approximately aligned with bearers below.

### Keep dry !

- If under cover, use good timber stacking practice
- If outside, use a weatherproof cover to keep dry and stack as per wet planks.
